Technical Booklet

1. LG Service News

3. Service Bulletins

LG Electronics Alabama, Inc. 2023. 09

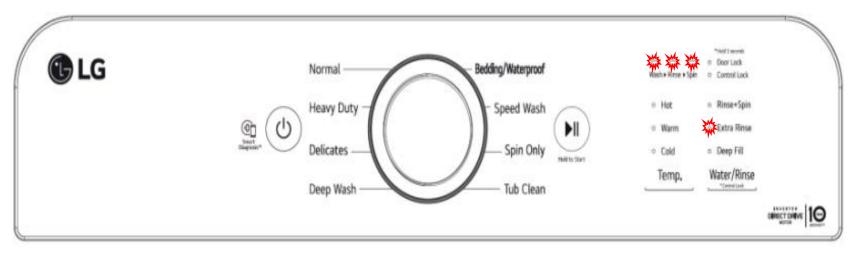
Unbalanced Error Code (UE Error)

UE Error: Wash/Rinse/Spin and Extra Rinse LED blinking

Cause #1: The unit is not properly leveled. \rightarrow Level the unit making sure the drum is centered properly.

Cause #2: The load is too small. \rightarrow Add additional items to allow the washer to balance the load.

Cause #3: Heavy articles are mixed with lighter items. \rightarrow Always try to wash articles of somewhat similar weight.

Cause #4: The load is out of balance. \rightarrow Manually redistribute the load if articles have become tangled.

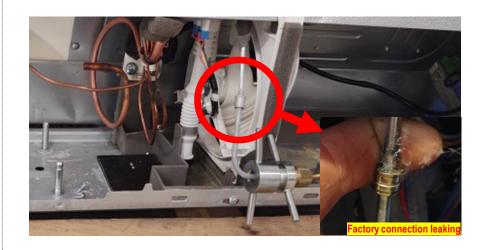
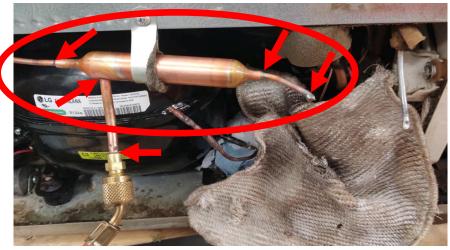
Right side are examples of improper isolations that need the driers and factory connection points removed because they sometimes leak and will trick you into thinking the yoder is bad. The goal is to eliminate all possible leak points outside of the yoder loop.

Above Example shows multiple potential leak points and why the drier needs to be removed for testing

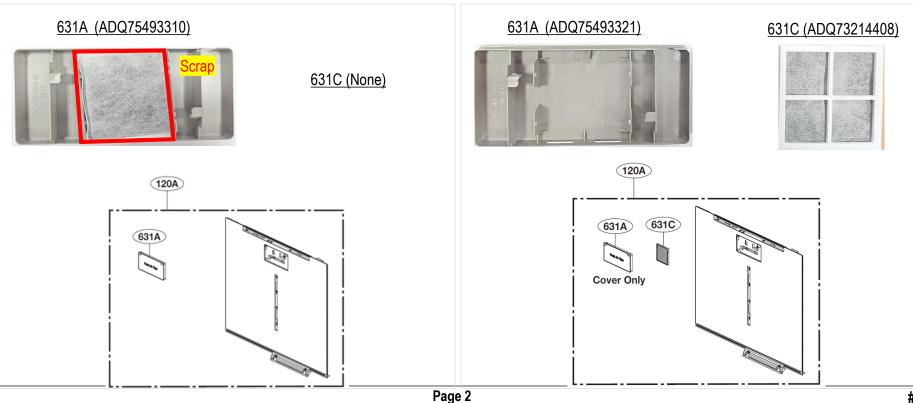
Symptoms	Air Filter (L into the air t	T120F) does not f îilter cover	fit		<u> </u>	Front View (Sam	<u>e)</u>	As Is Slanted	Back Vie	w <u>To Be</u> Square
Cause	Air Filter Sta Affected par	Indardization ts : Air filter cover	, Duct assembly	Picture	(Open	Fresh Air Filter	Carry

1. Replace with the new parts

2. Current and New (Visual / Part number & Name etc)

Na	SVC	Description	Demoril		
No	Location	Description	Current	New	Remark
			ADJ75352113	ADJ75352123	Change
2	120A	Duct Accombly Multi	ADJ75352116	ADJ75352124	Change
ა	IZUA	Duct Assembly,Multi	ADJ75352117	ADJ75352125	Change
			ADJ75352118	ADJ75352126	Change

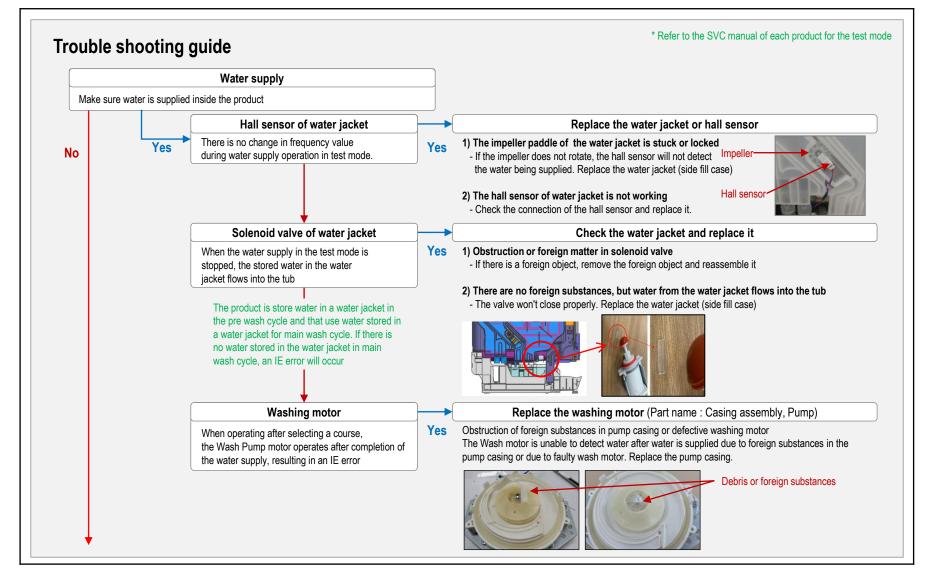
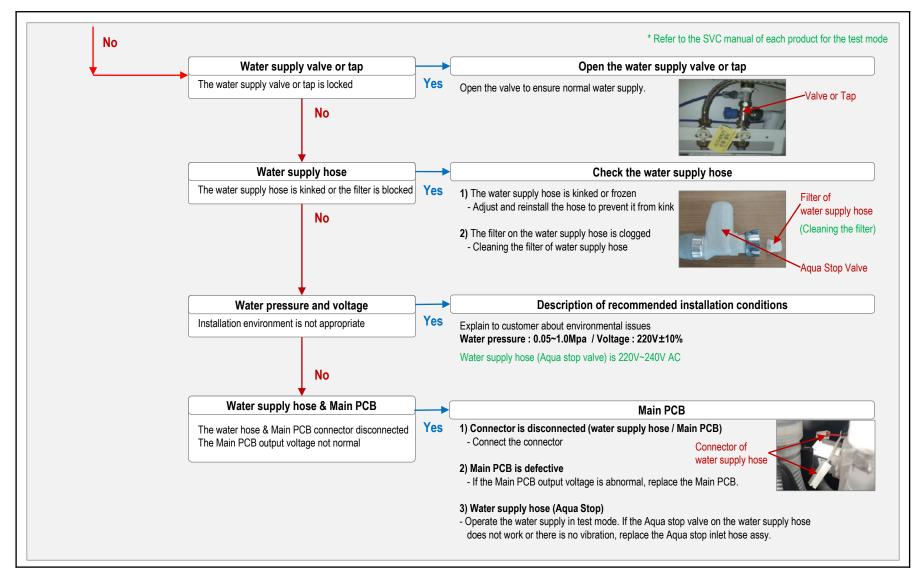
IE errors occur when water is not supplied to the product or when water is not detected

Error detecting period	Error sensing condition	Detailed action	Possible Cause	Solution
Water Supply Section	 30Hz of water supply frequency detection for more than 30seconds If the water supply does not meet the set value within 10 minutes The washing motor does not detect the water supplied normally 	(Drain 30s + Pause) × 4times	 The water supply valve or tap is locked The water supply hose is kinked or frozen The water pressure is too high or too low The filter on the water supply hose is clogged The valve of water supply hose is not working The voltage is too low The connector of water supply hose is disconnected The impeller of water jacket is stuck The hall sensor of water jacket is not working The solenoid valve of water jacket is defective Incorrect detection of washing motor Main PCB is defective 	 Open the water supply valve or tap Adjust the water supply hose Check the water pressure (0.05~0.6Mpa) Cleaning the filter of water supply hose Replace the water supply hose Check the voltage (220V ± 10%) Connect the connector of water supply hos Replace the water jacket Replace the solenoid valve or water jacket Replace the washing motor Replace the main PCB

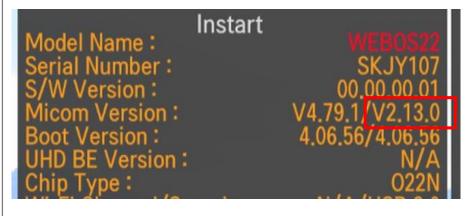
1. Symptoms					
Category	Case1 Case2				
Symptom	No video or image on TV screen Keep display guide image issue				
Reproduce procedure	 ① Power off by magic remote and disconnect Box power ② Plug Box power cord and power on (TV is under pixel refresher process) ③ There's no video or image on TV screen (TV is still under pixel refresher process and the process is not done) 	 Let Box unplugged and wait more t TV display would turn off after a mo TV on by remote controller (the B The TV screen keep display guide i (TV display should turn off after 5 	oment Box is still unplugge image	Instart WEBUSZZ Serial Number : SKJY107 J) S/W Version : 00 00 00 11 Micom Version : V4.79.1 V2.13.0 Boot Version : 4,06.56/#.400.00 N/A UHD BE Version : N/A Chip Type : 022N	
Quick Fix	Unplug and plug TV display power cord	Plug Zero connect Box power cord a	and TV on by remot	te controller	
Primary Solution	y Solution Perform Micom FW update by using USB update file (Follow symptoms occur at specific version of Micom (same or less than V2.12.0))

• Perform Micom FW update by using USB update file (Micom FW is not supported by network update)

- 4. After service SW version check the following;
- Micom version (second section): check V2.13.0.
